Journal of Orthopaedics, Trauma and Rehabilitation

Case Report

Interprosthetic Fracture of Distal Femur Around Total Knee Replacement with Pre-Existing Dynamic Condylar Screw 發生在股骨遠端,介乎於動力髁螺釘和全膝關節置換假體之間的骨折: 病例報告

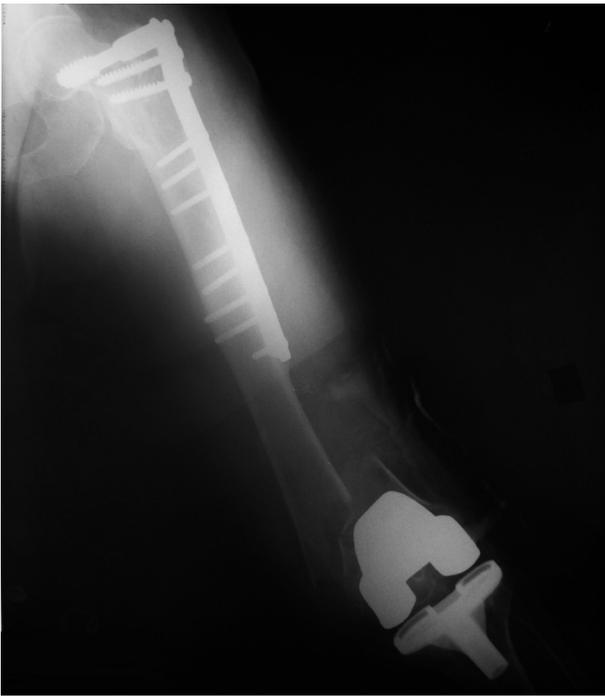
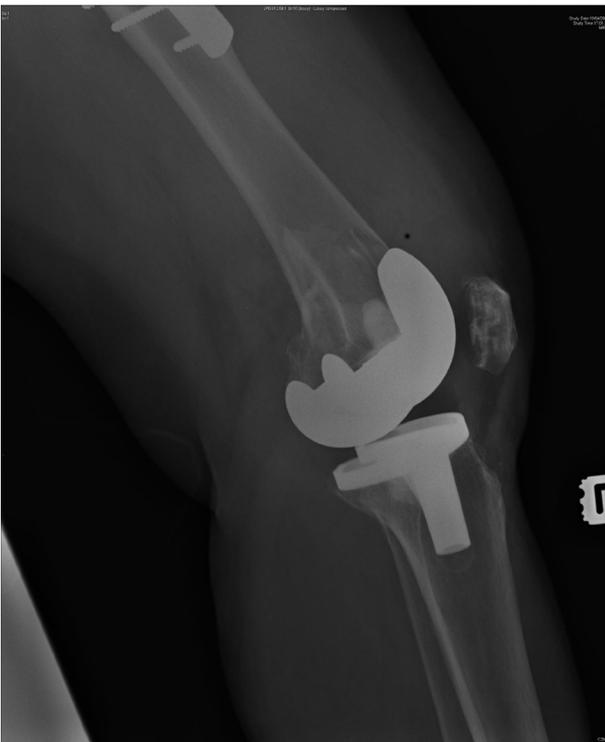
Figure 1. Post-injury film showing inter-prosthetic fracture of the left distal femur.

has no documented history of osteoporosis, steroid use, metabolic disease, or malignancy. Physical examination revealed swelling and deformity over the left distal femur. Radiography showed a displaced interprosthetic fracture of the left distal femur around a well-fixed TKR (Rorabeck type II)² (Figure 1). Moreover, there was a well-fixed DCS for a healed subtrochanteric fracture in the ipsilateral proximal femur.

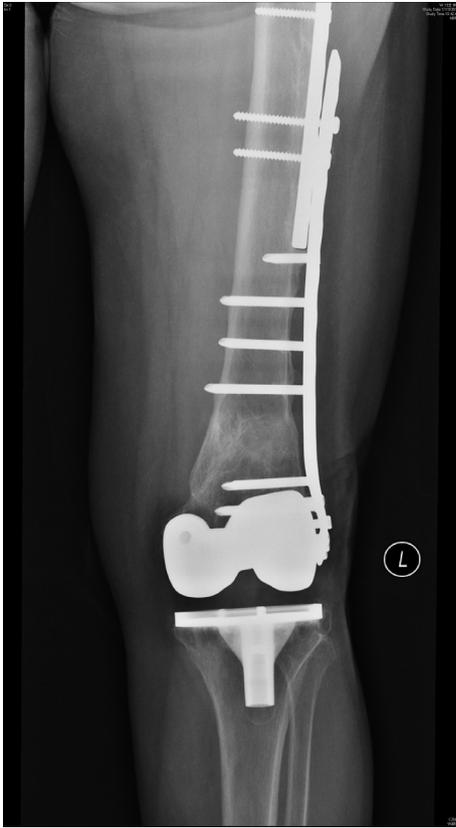
Figure 3. Latest follow-up in 2012 shows good bone healing and satisfactory alignment.

Postoperative radiography showed satisfactory alignment (Figure 2). Continuous passive motion exercise was used to improve the range of movement of the knee. The patient was instructed to maintain non-weight-bearing walking with a hinge brace. The weight-bearing status was gradually stepped up according to clinical and radiological findings of healing during subsequent follow-up. At 8 months postoperatively, the patient was started on full weight-bearing walking and 9 months postoperatively, the fracture was healed. At 1 year after surgery, the range of motion of the knee was 0–90°. The patient was able to walk satisfactorily with a cane. After 3 years postoperative follow-up, the alignment and implant were maintained (Figure 3).
